Component Cleanliness Testing: ‘The good, the bad, and the ugly’ regarding Extraction Validation aka Reduction Curves

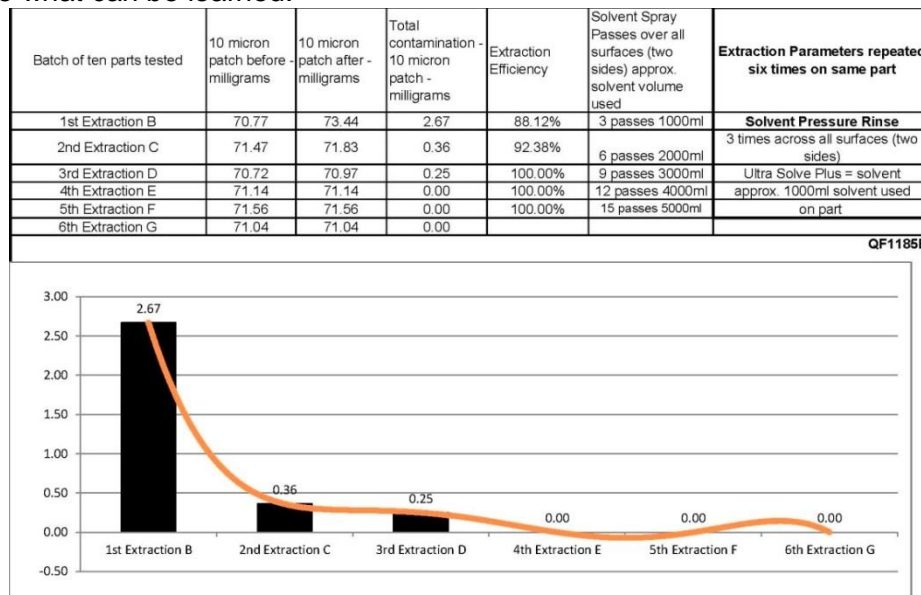
In Figure 1 (above) we see a “good” Extraction Validation test. Excellent reduction of contamination was achieved right away and reduction continued during extractions 2 and 3. This suggests that the tested extraction formula/recipe was well chosen based on a quick glance at the chart. The target of

90+% Extraction Efficiency or <10% remaining contamination on the part (or batch of parts) was achieved after two extractions and the fourth, fifth, and sixth extractions all showed no measurable mass of contamination. This is an example of what a “good” extraction validation curve based on Mass looks like. (Don’t however expect to get repeated zeros – it doesn’t happen that way every time – for a variety of reasons.)

In Figure 2 (above) we see that the extraction formula/recipe derived from the testing done in Figure 1 produced 84.72% Particle Reduction when tested for Particle Count reduction rather than Mass reduction. The target in this case was 70+% Particle Reduction (per the OEM spec in this instance) so this EV was “good” for both Mass reduction and Particle Count reduction.

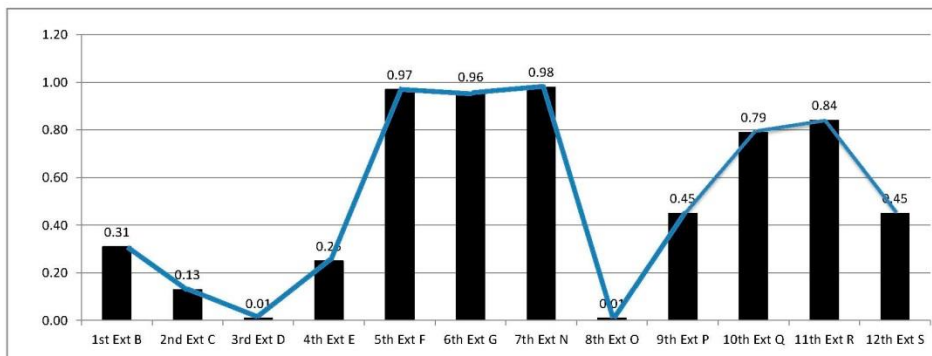
So now it's time to look at some "ugly" results that do something quite unexpected. These types of results are something the cleanliness testing technician really doesn't want to see but they do occur so let's look at an example and see if we can learn something. (See Figure 5 below) On this "ugly" extraction validation you see that the target of 90+% extraction efficiency was "allegedly" (mathematically) achieved by the second extraction. You would have never known it would turn "ugly" if you stopped there. But then the fourth extraction had nearly as much Mass as extraction one and the fifth and sixth extractions each had three times the Mass of extraction one. The "ugliness" lead us to do an additional six extractions which themselves showed more "ugliness" – definitely not the neat and tidy reduction you want to see. So what could cause the "ugliness" in the fortunately rare examples of "ugly" extraction validations? Here's a short list (not all inclusive by any means) of some possible causes: part material incompatible with extraction fluid; inappropriate extraction fluid which is unable to quickly dissolve residual material from process fluids including Rust Preventative; material characteristic of being prone to shedding of particles ad infinitum (cast metals, powdered/sintered metals, etc.); surface treatment which flakes or sheds (plating, paint, etc.) or has potential to entrap then later release particles (shot blasting, etc.).

Once you have “ugly” extraction validation results you are faced with the challenge to figure out what happened so that an appropriate extraction method can then be developed. It can be fairly simple if the extraction fluid degrades the material being extracted or doesn’t quickly dissolve residual materials from process fluids – that “simply” requires an appropriate extraction fluid to be chosen. But some of the other potential causes of “ugly” extraction validation results can be a LOT more complicated to remedy IF they can be remedied at all in the near term. Persevere.
